INDOOR AIR QUALITY ASSESSMENT

**Abigail Adams Intermediate School
89 Middle Street
E. Weymouth, Massachusetts**

Prepared by:
Massachusetts Department of Public Health
Bureau of Environmental Health Assessment
February, 2002

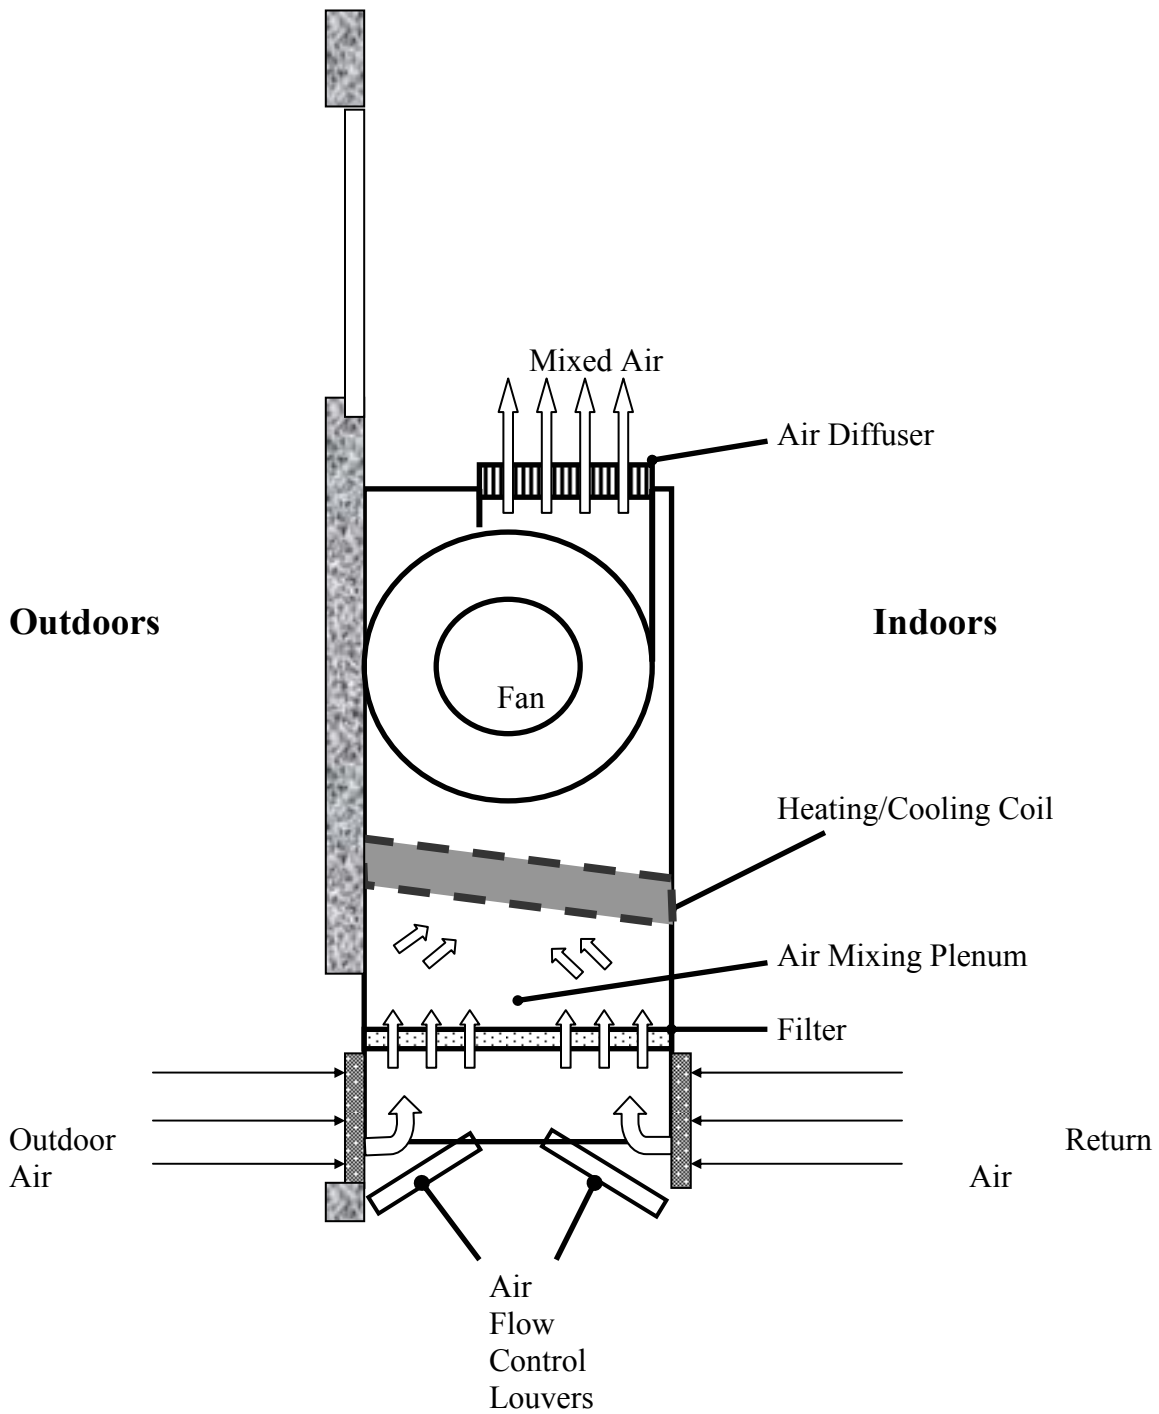
Figure 1

Fresh air in exterior classrooms is supplied by a unit ventilator (univent) system. Univents draw air from outdoors through a fresh air intake located on the exterior walls of the building and return air through an air intake located at the base of each unit (see [Figure 1](#)). Fresh and return air are mixed, filtered, heated and provided to classrooms through a fresh air diffuser located in the top of the unit. Interior classrooms, offices and common areas are ventilated by rooftop air handling units (AHUs), which are ducted to ceiling-mounted air diffusers and wall-mounted exhaust vents. Univents and AHUs were operable in all areas surveyed.

Unit Ventilator (Univent)
